Industrial Paste-Grade Lining for Protection Against Abrasive Attack

Belzona 1812 (Ceramic Carbide FP) is a two-component repair and protective coating for the protection of surfaces subject to abrasive attack.

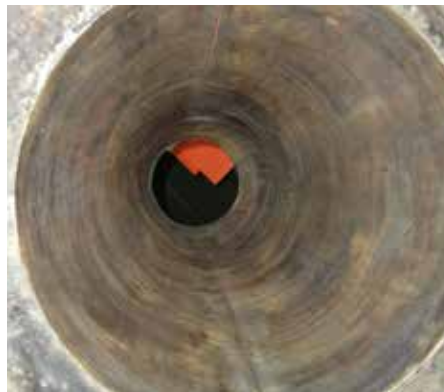
Steel cone before coating

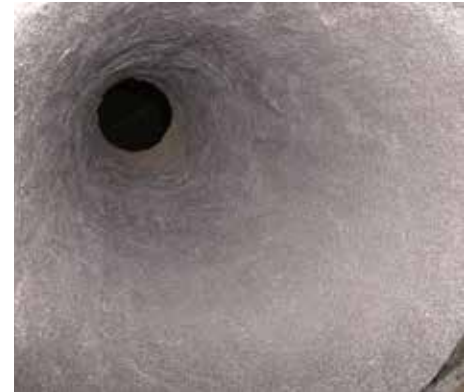
Steel cone coated in Belzona 1812
